**AMADA MIYACHI AMERICA, INC.**

## E13: Deionize Trouble E54: Deionize Caution

### Troubleshooting Deionize Errors

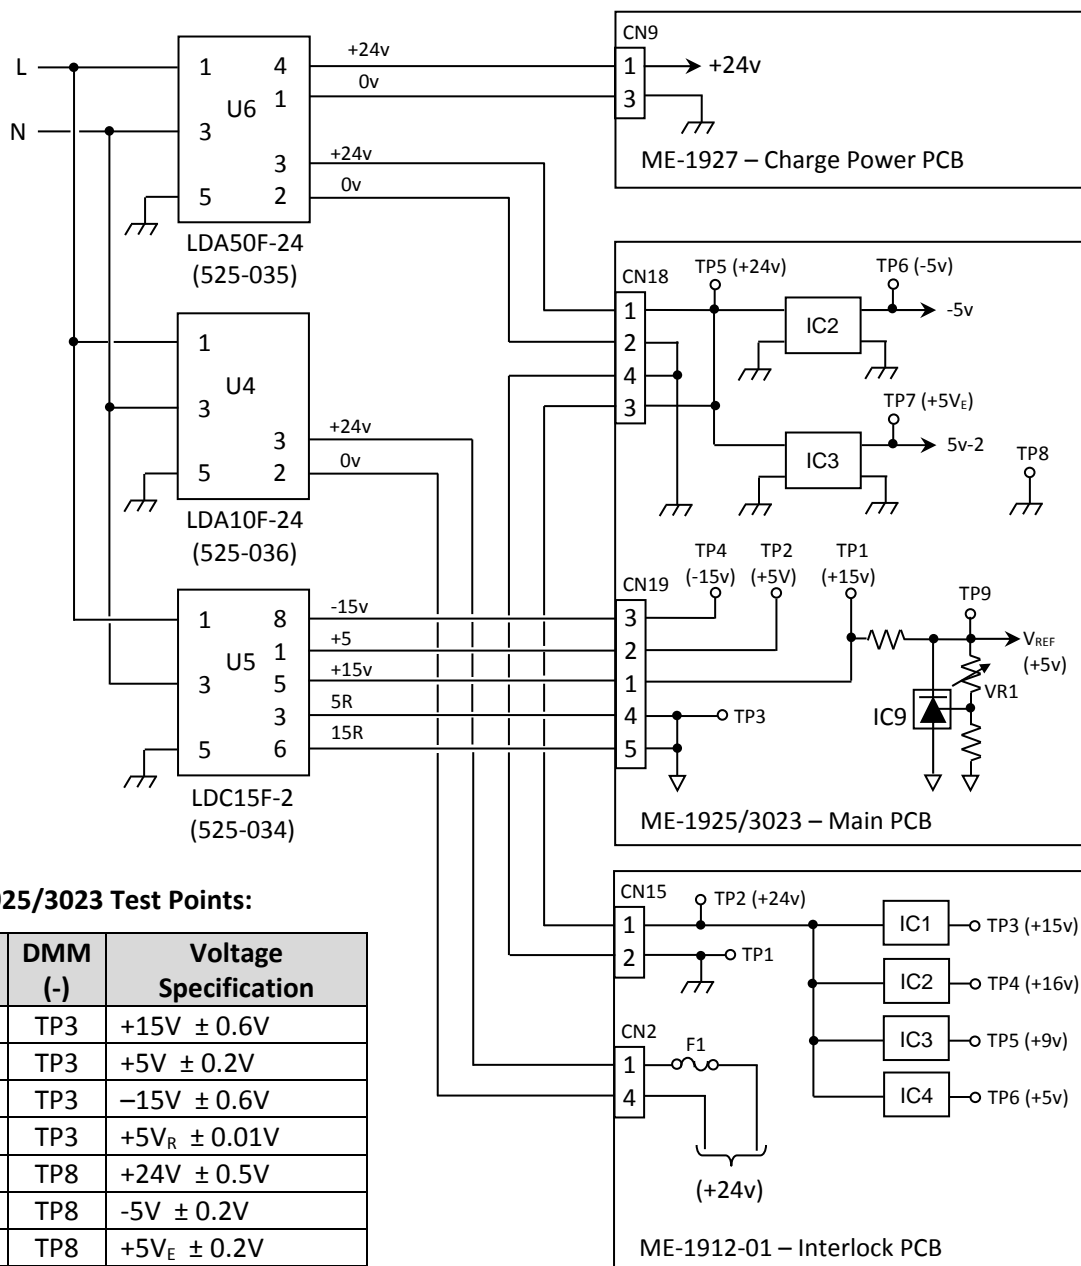
**LW5A(M)/15A/25A/2AG/5AG Laser Welders (8-xxx-01-xx)**

An **E13** or **E54** error can also be caused by faulty Power Supply voltage. Typically a power supply fault will also yield other error messages as well. Using a DMM, measure the power supply voltages on the **CPU** (Main PCB) at the appropriate test points (see tables below for a list of test points and expected voltages). If all voltages test OK, continue with the next step. If there is a problem with one or more of the power supply voltages, isolate the failure based on the schematics below. Refer to the AMYA Support site ([www.amyasupport.com/lsd](http://www.amyasupport.com/lsd)) under "Service" for more information on component / test point locations.

U4, U5 and U6 are mounted to the inside chassis wall behind the Main PCB and Interlock PCB.

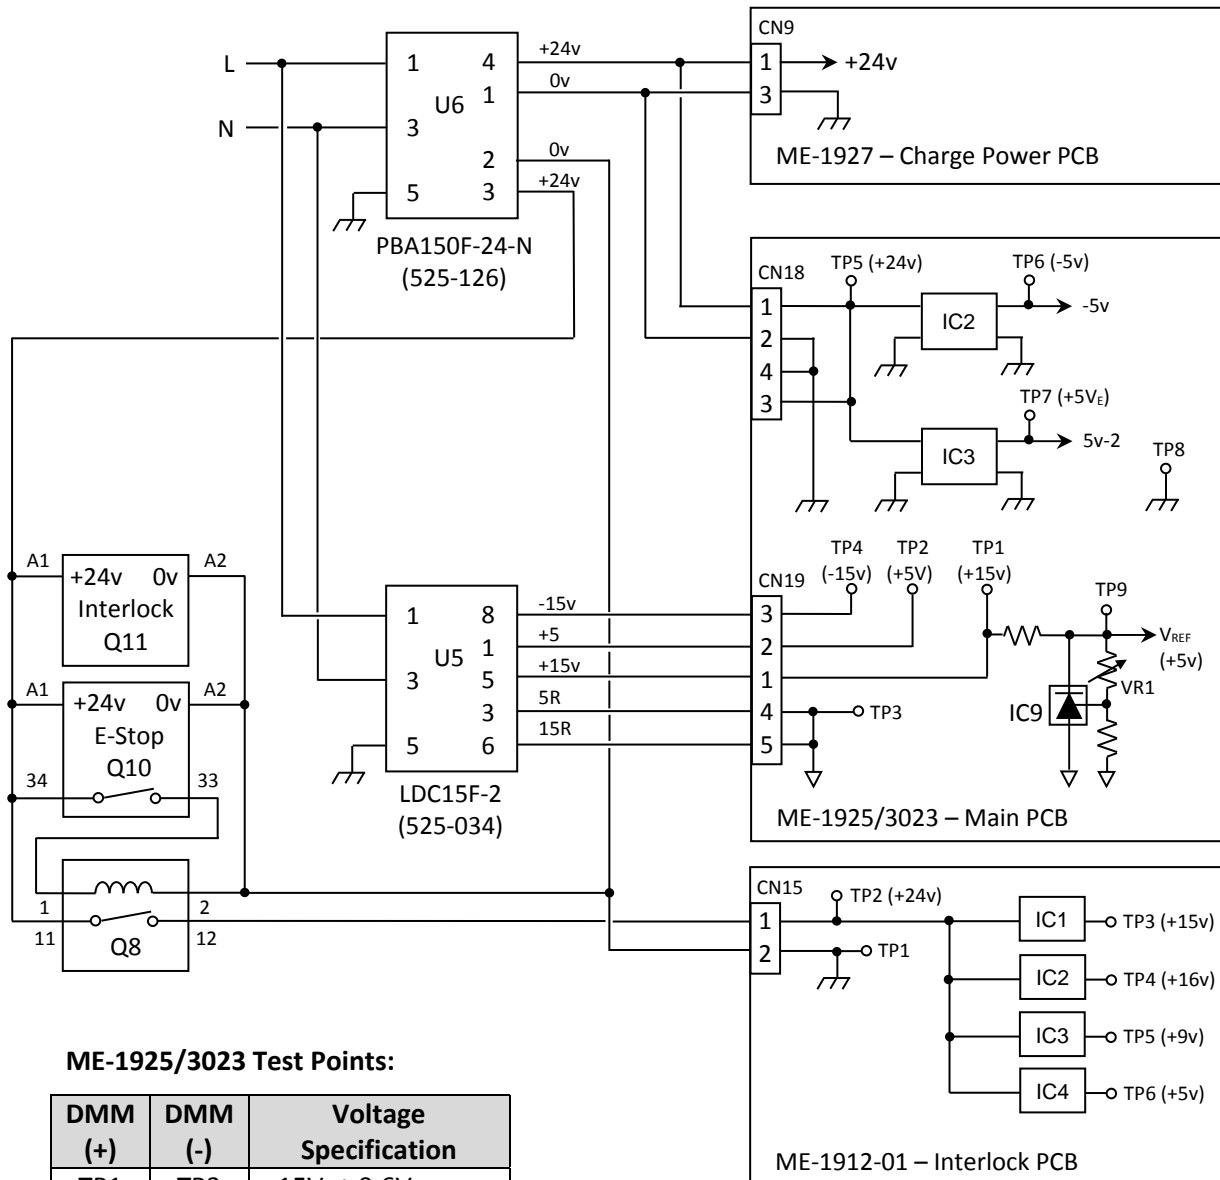
**LW5A(M)/15A/25A/2AG/5AG Laser Welders (8-xxx-02-xx)**

Power Supplies U5 & U6 are mounted to the inside chassis wall behind the Main PCB and Interlock PCB. Safety Relays Q10 / Q11 and relay Q8 are mounted on the chassis wall just below the Main PCB.

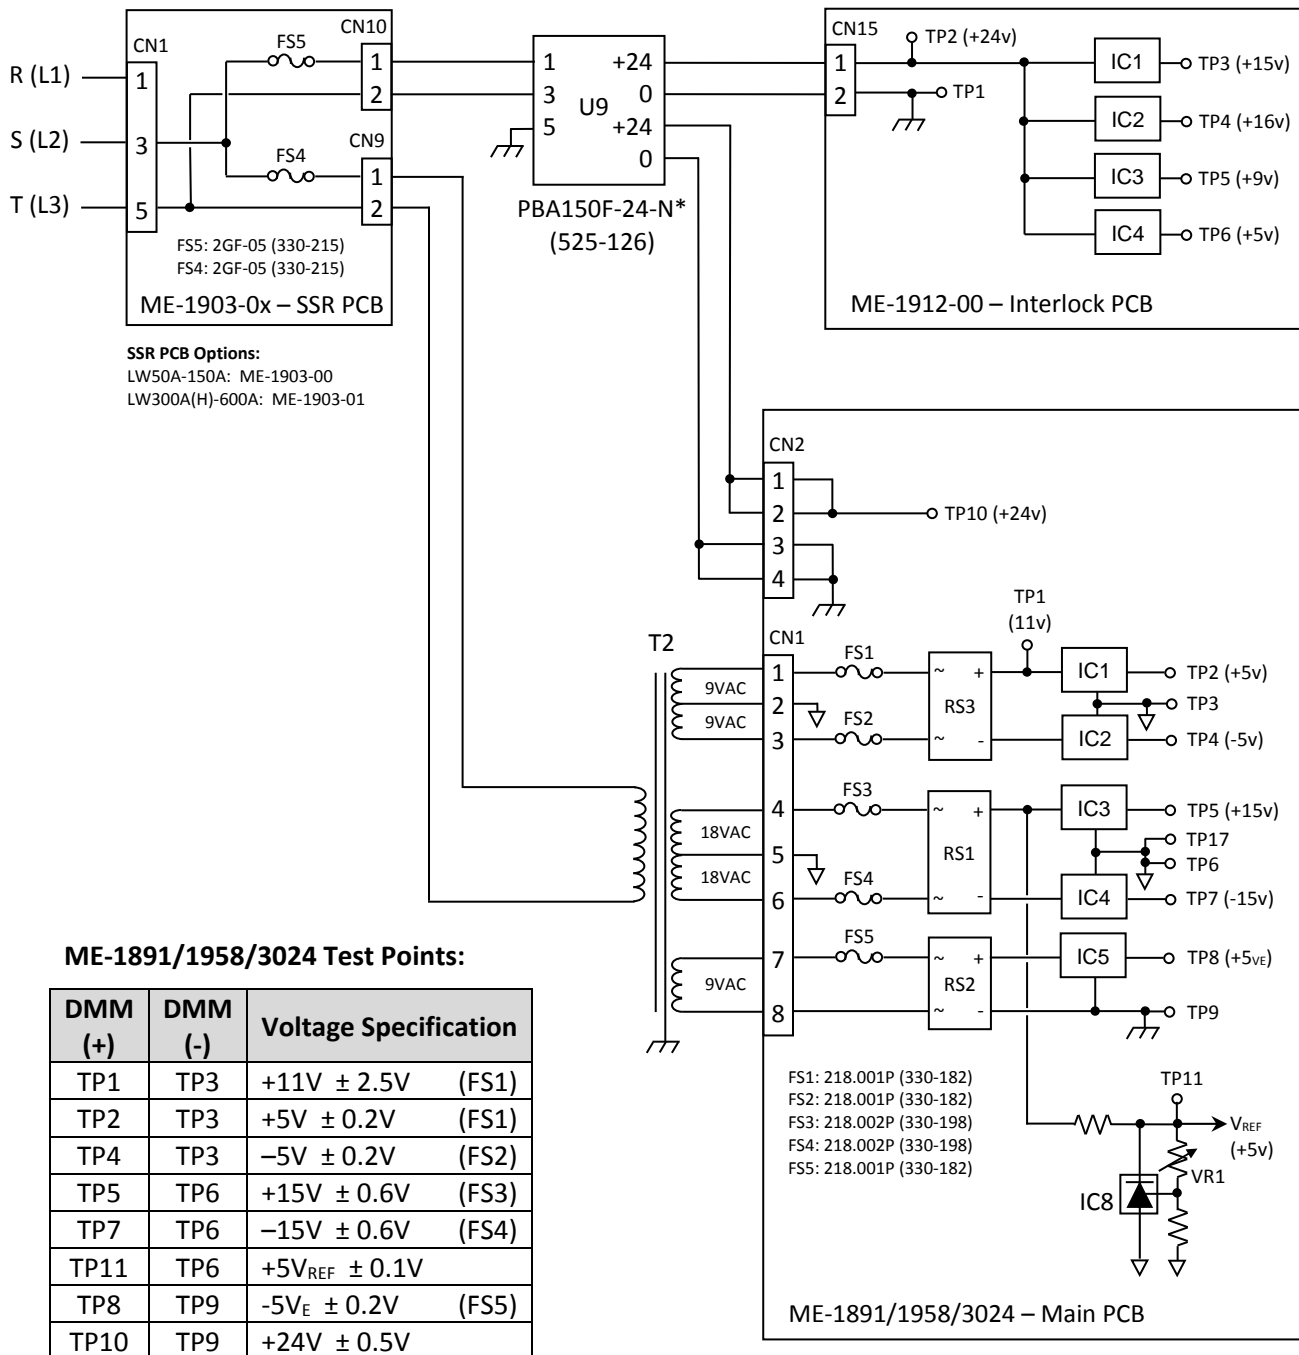
**LW50A(C)/70A(C)/150A/300A(H)/400A/500A/600A Laser Welders (8-xxx-01-xx)**

\* At the time of this document's publish date, Power Supply U9 shown above is typical for 220VAC U.S. LW50A/70A/150A Laser Models. However, depending on the Laser Model, Date of Manufacture and destination country, Power Supply U9 may be different than shown. If a faulty power supply is found, read the model number of the power supply itself in order to determine the correct replacement.

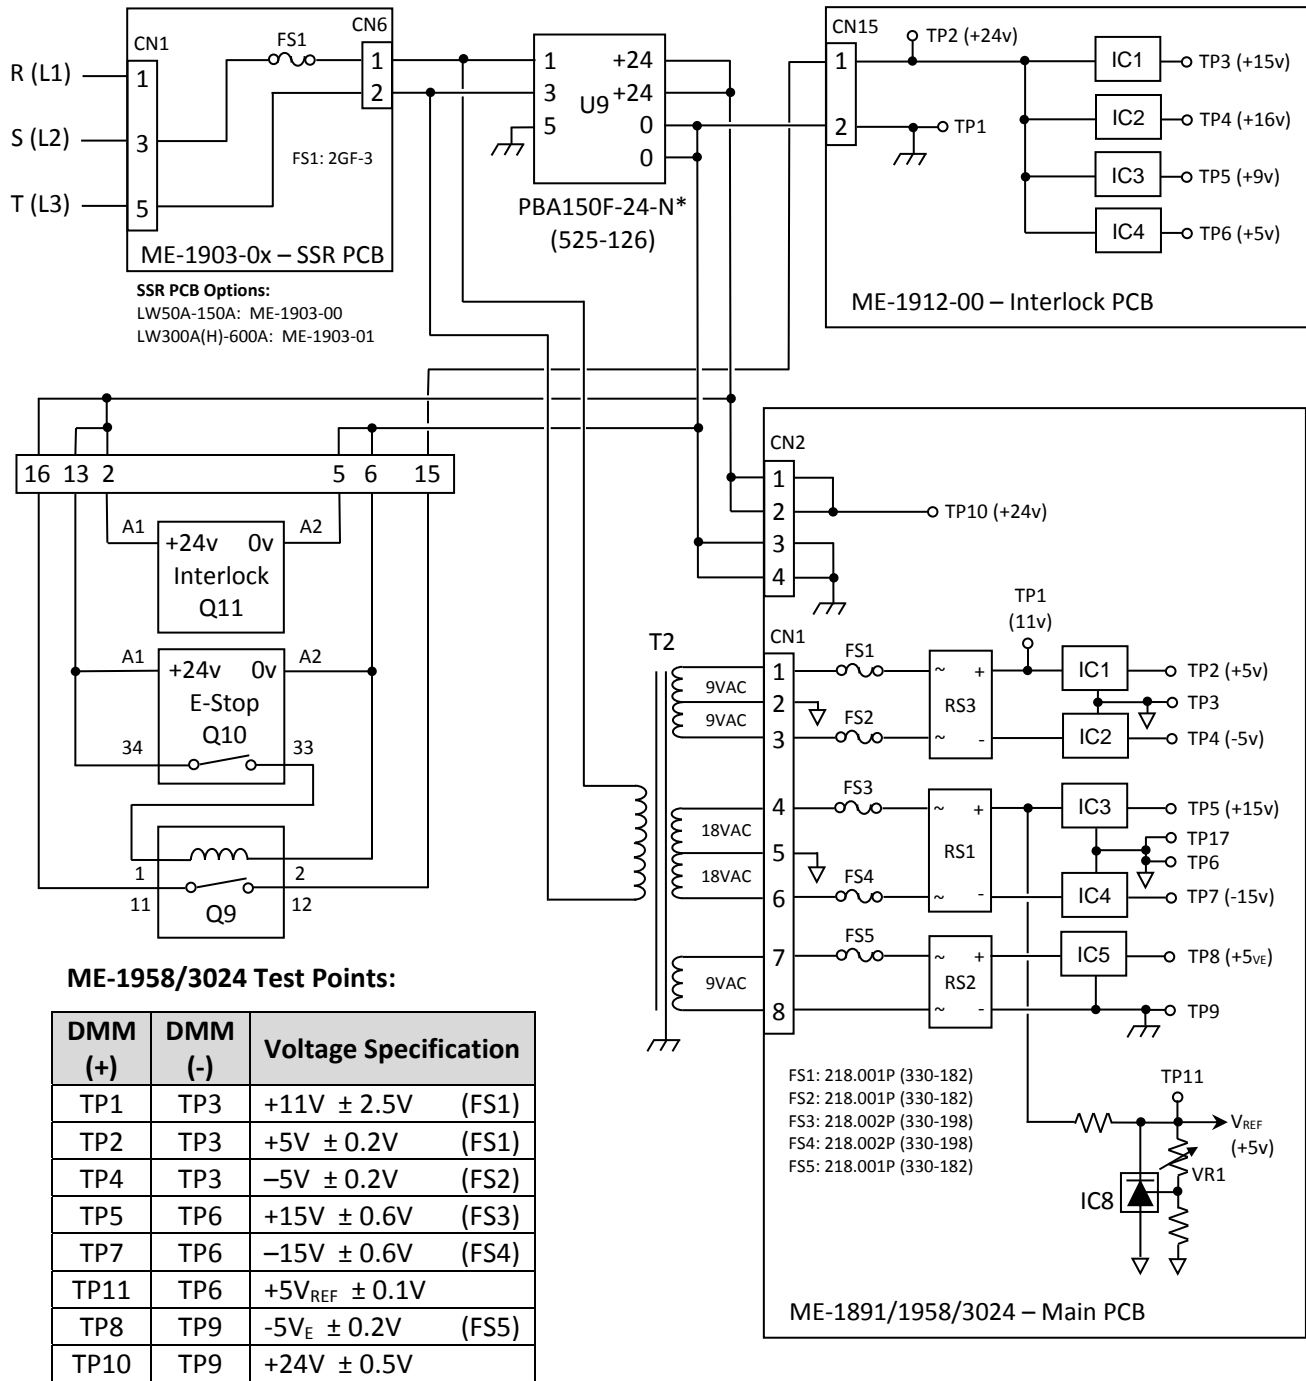
**LW50A(C)/70A(C)/150A/300A(H)/400A/500A/600A Laser Welders (8-xxx-02-xx)**

\* At the time of this document's publish date, Power Supply U9 shown above is typical for 220VAC U.S. LW50A/70A/150A Laser Models. However, depending on the Laser Model, Date of Manufacture and destination country, Power Supply U9 may be different than shown. If a faulty power supply is found, read the model number of the power supply itself in order to determine the correct replacement.

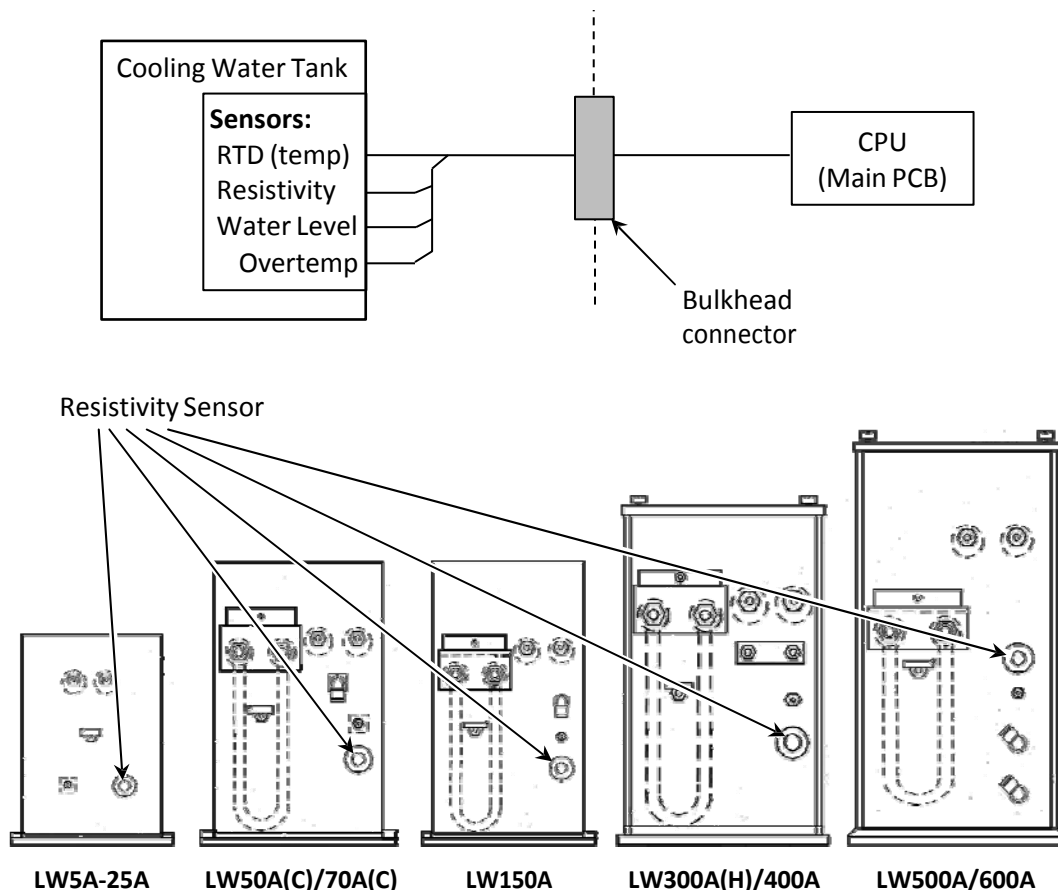
Occasionally a connection problem may arise between the resistivity sensor and the CPU (Main PCB). The resistivity sensor is physically located on the Cooling Water Tank. The resistivity sensor is wired to bulkhead Molex style connector that is mounted to the chassis near the water pump assembly. Sometimes the bulkhead connector gets corroded (especially in harsh operating environments). The bulkhead connector can be located by following the wires from the resistivity sensor to the bulkhead connector. If the bulkhead connector is corroded, the contacts can be cleaned with contact cleaner or simply repetitive connect/disconnects. The locations of the bulkhead connectors vary among Laser models.

If the bulkhead connection cannot be verified, continue with the next troubleshooting step in order to test the resistivity sensor connections. The results of the next step will verify the bulkhead connection.

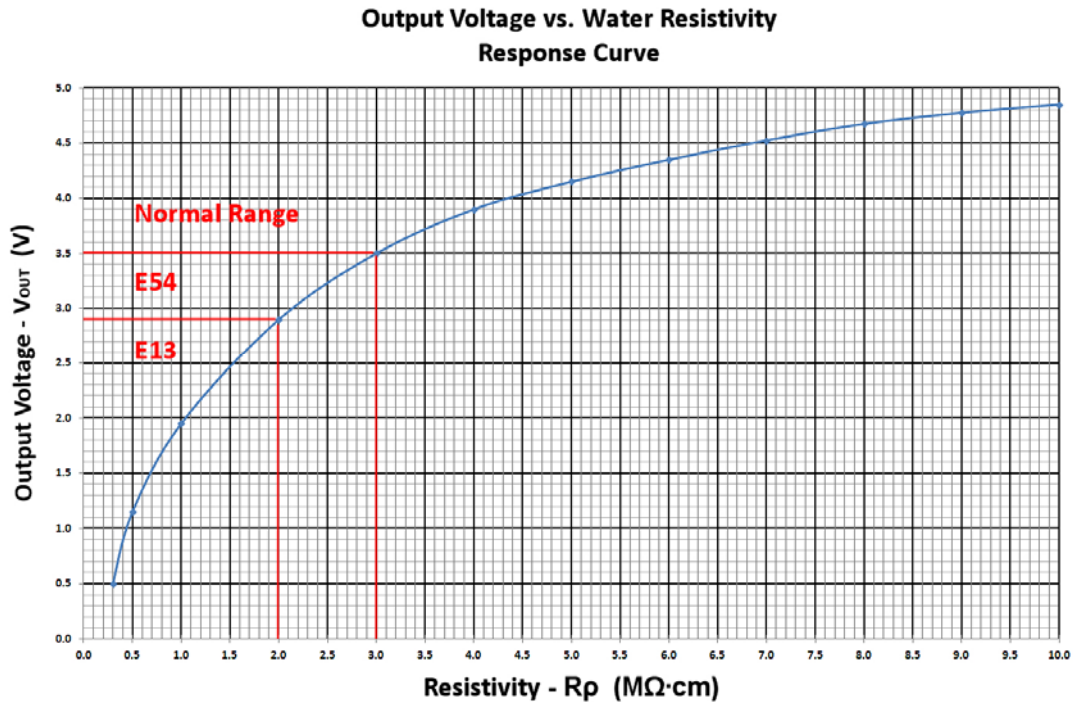
It is very rare for a Resistivity Sensor to go bad. In order to rule out a faulty sensor, this section describes “how to test it”. The Resistivity Sensor circuit is a simple voltage divider that works by applying a small current between two probes physically spaced 2mm apart and using the water as the conductive medium ( $R_p$ ). As the resistivity of the water increases, the voltage divider output ( $V_{OUT}$ ) also increases. This output voltage ( $V_{OUT}$ ) is then measured by the  $\mu P$  (microprocessor) on the Main PCB and the resistivity value is then calculated and displayed on the LCD screen. The response of the Resistivity Sensor is shown below.

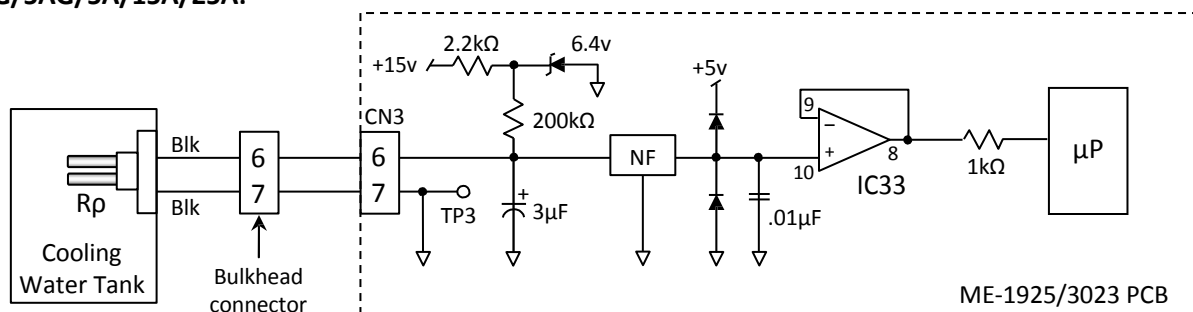
#### LW2AG/5AG/5A/15A/25A:

If the DMM measures 0 v at all times, then look for a short between the Resistivity Sensor and the Main PCB.  
 If the DMM measures  $> 4.6$  v at all times, then look for an open between the Resistivity Sensor and the Main PCB.  
 For convenience, the schematics for both the ME-1925/3023 and ME-1958/3024 Main PCB's are shown below for reference.

If the Resistivity Sensor is determined bad, then it would be easiest to replace the complete Resistivity Sensor assembly (harness + sensor probes + housing). Refer to the table below for the correct replacement part numbers. Please note that the majority of these parts are not normally stocked and will be special order.
